HIGHWAY ACCIDENT REPORT

School Bus and Dump Truck Collision
Central Bridge, New York
October 21, 1999

**NTSB/HAR-00/02
PB2000-916202
Notation 7302
Adopted November 14, 2000**

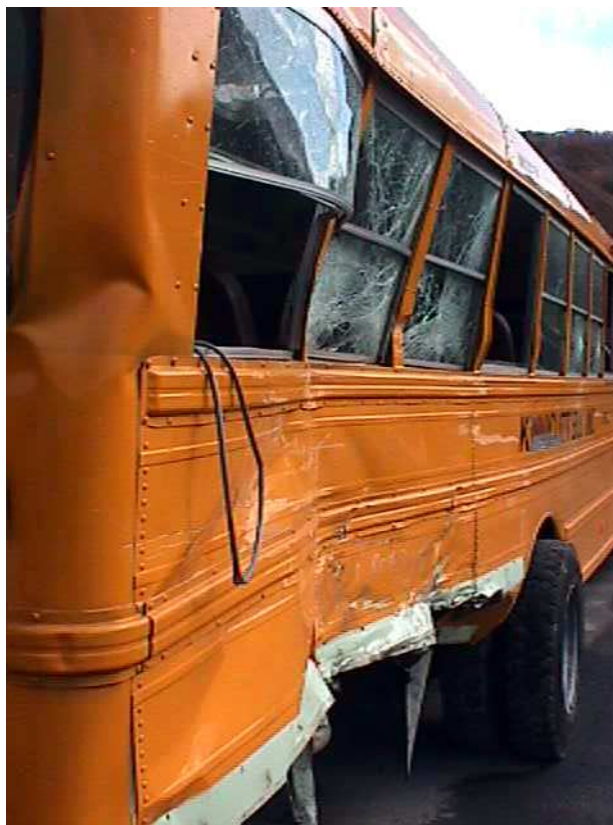
Figure 1. Exterior crush damage of school bus.

As the school bus approached the intersection, according to the chaperons, several children on board saw the sign for the Pumpkin Patch that was beyond the intersection and yelled. These children may also have released their belt buckles. One child reportedly stood up in the seating compartment. The busdriver, who was looking for SR-7, told investigating police that he saw the posted stop sign, slowed, but did not stop the bus, which then entered the intersection where the dump truck struck it on the right side behind the rear axle. (See figure 1.)

The Safety Board documented the impact damage to the school bus. The vehicle's fiberglass hood assembly was damaged and displaced at the forward hinge. The engine frame mounting and transmission bell housing were fractured, causing the engine and transmission to sag downward. The chassis' main frame rails were displaced to the left about 5.75 inches from their longitudinal axis. The bus body had 15 inches of intrusion on the right side behind the right rear axle. (See figure 1.) In addition to this contact damage, the bus had induced damage to side posts, roof bows, corner reinforcements, window frames and glass, the rear emergency exit door and frame, interior and exterior sheet metal and reinforcements, and the entrance door step well and frame area. The body-to-chassis mounting clips were found separated at the frame rail and at the floor panel deformation.

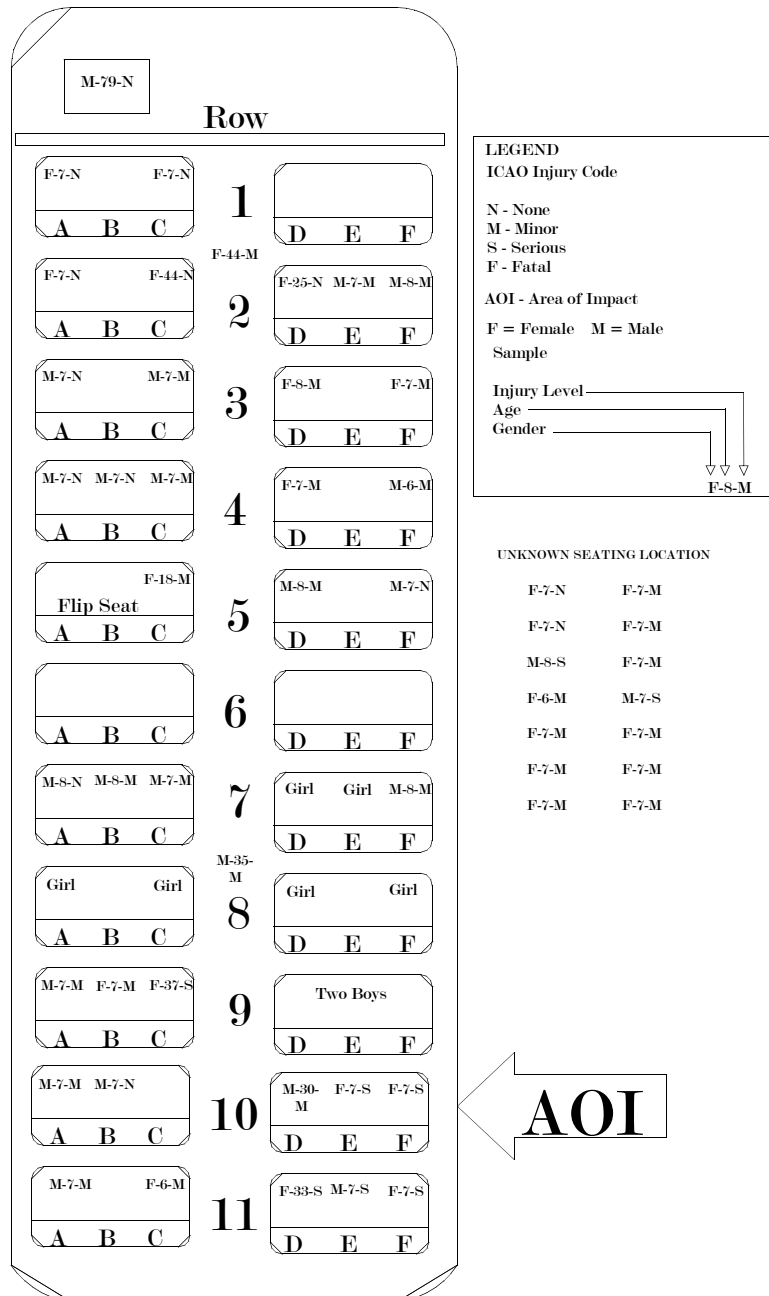
Figure 4. School bus seating and injury diagram.

Serious injuries included vertebra and skull fractures and internal injuries. Minor injuries included lacerations, abrasions, and neck strains. The most seriously injured passengers were seated in the area of impact. (See figure 4.)

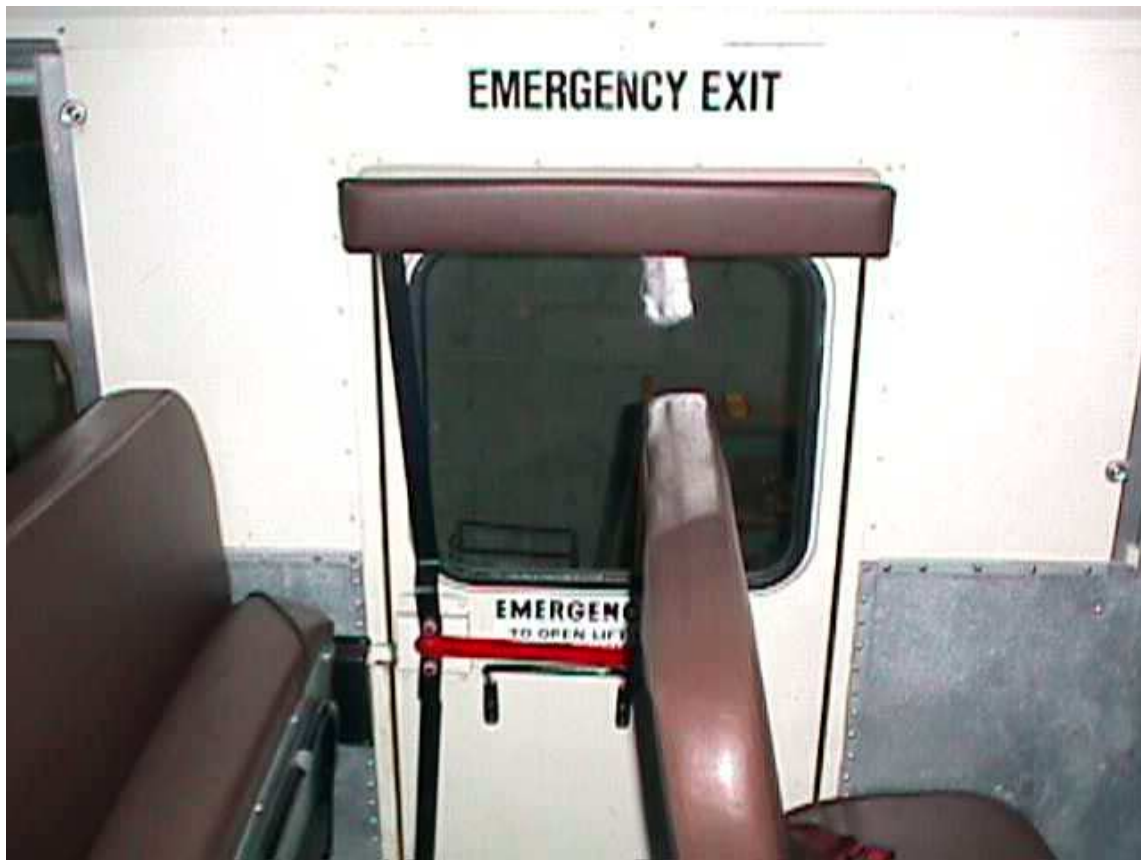
Figure 5. View of side emergency door and “flip-up bottom” seat in the up position.

The side door had a release mechanism to allow occupants to open the door from the inside in the event of an emergency. (See figure 5.) The release mechanism consisted of a horizontal metal bar attached at one end with two bolted vertical locking rods. When in the locked position, the locking rods rest in apertures above and below the door. When the horizontal bar is pulled upward 90 degrees, the motion causes the two locking rods to move out of the apertures, and the door is released.

In this accident, a lap-belted chaperon (see 5C in figure 4) was in the flip-up bottom seat¹⁷ adjacent to the side emergency exit door (see figure 5). Due to the dynamics of the collision, she was not initially propelled laterally into the door. However, the chaperon stated that after impacting the seat in front of her, she then fell toward the side emergency exit door. She sustained a left wrist strain and a thumb fracture.
